Los Padres Fish Passage Evaluation

A Study Out of a Suitcase

Los Padres Dam

RM 24.8 of the
Carmel River

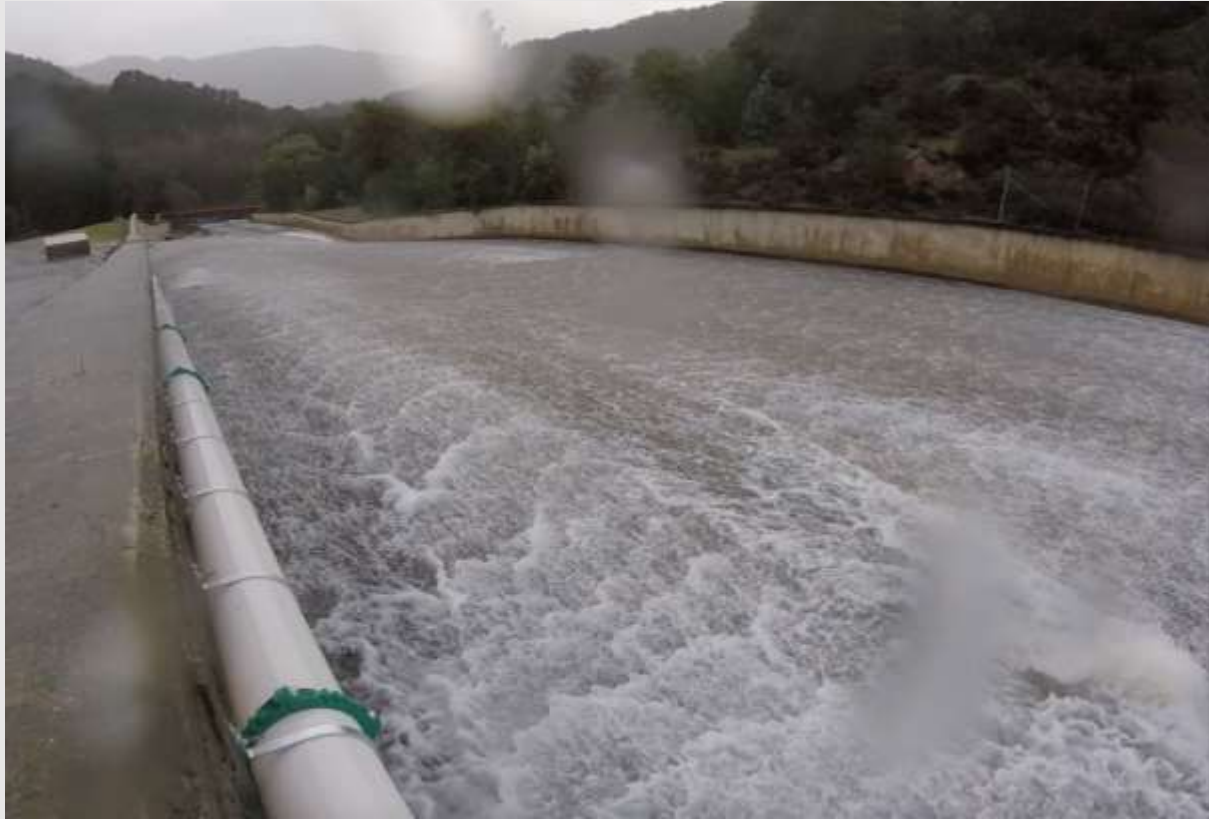
Shallow spillway flow

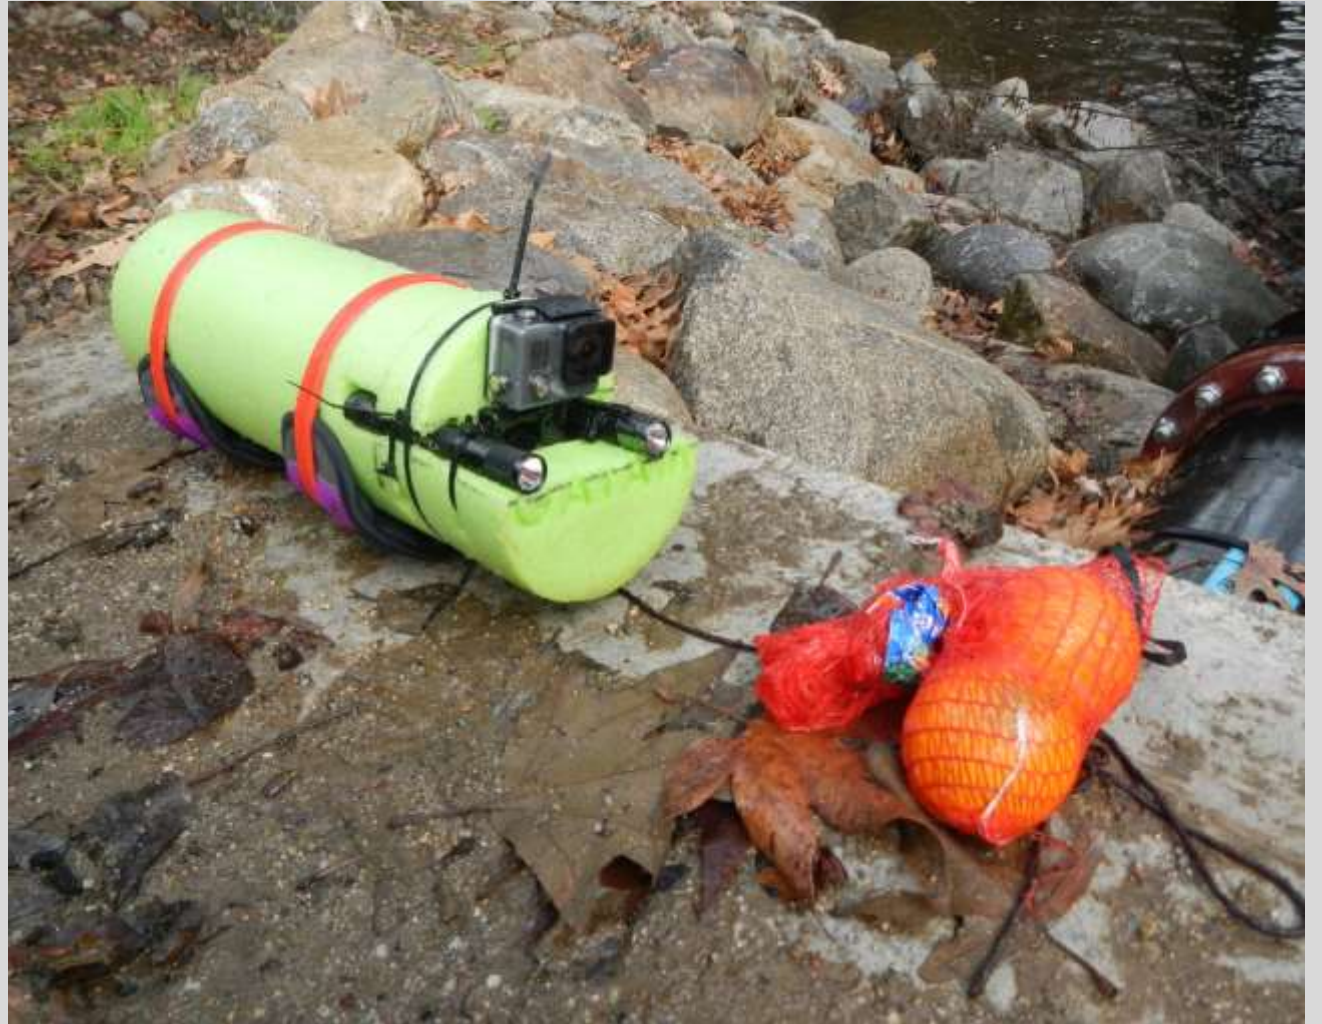
- Video within the bypass
- 3 flows: 3cfs, 5cfs, 9 cfs
- Assess potential mechanical or hydraulic issues within the bypass

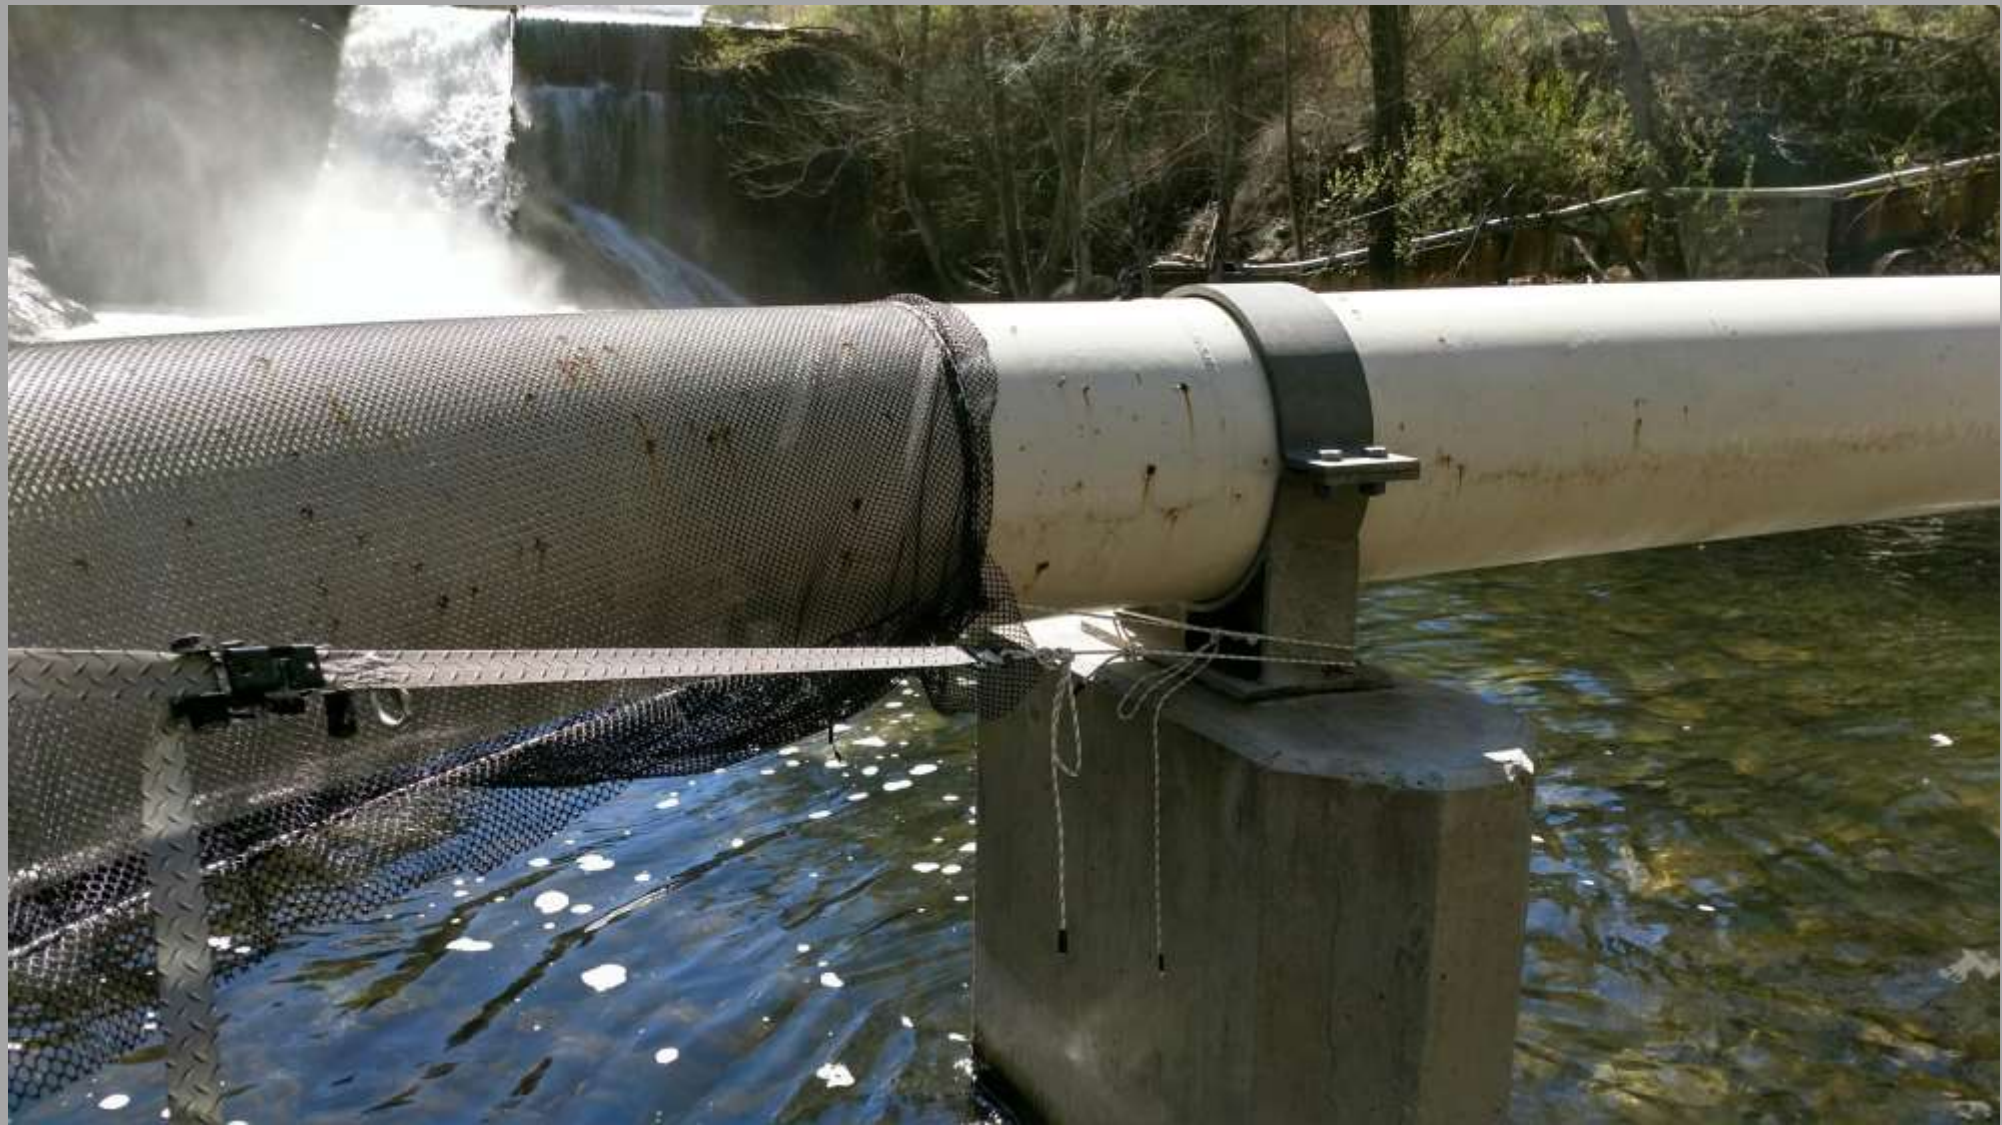
Net flume configuration

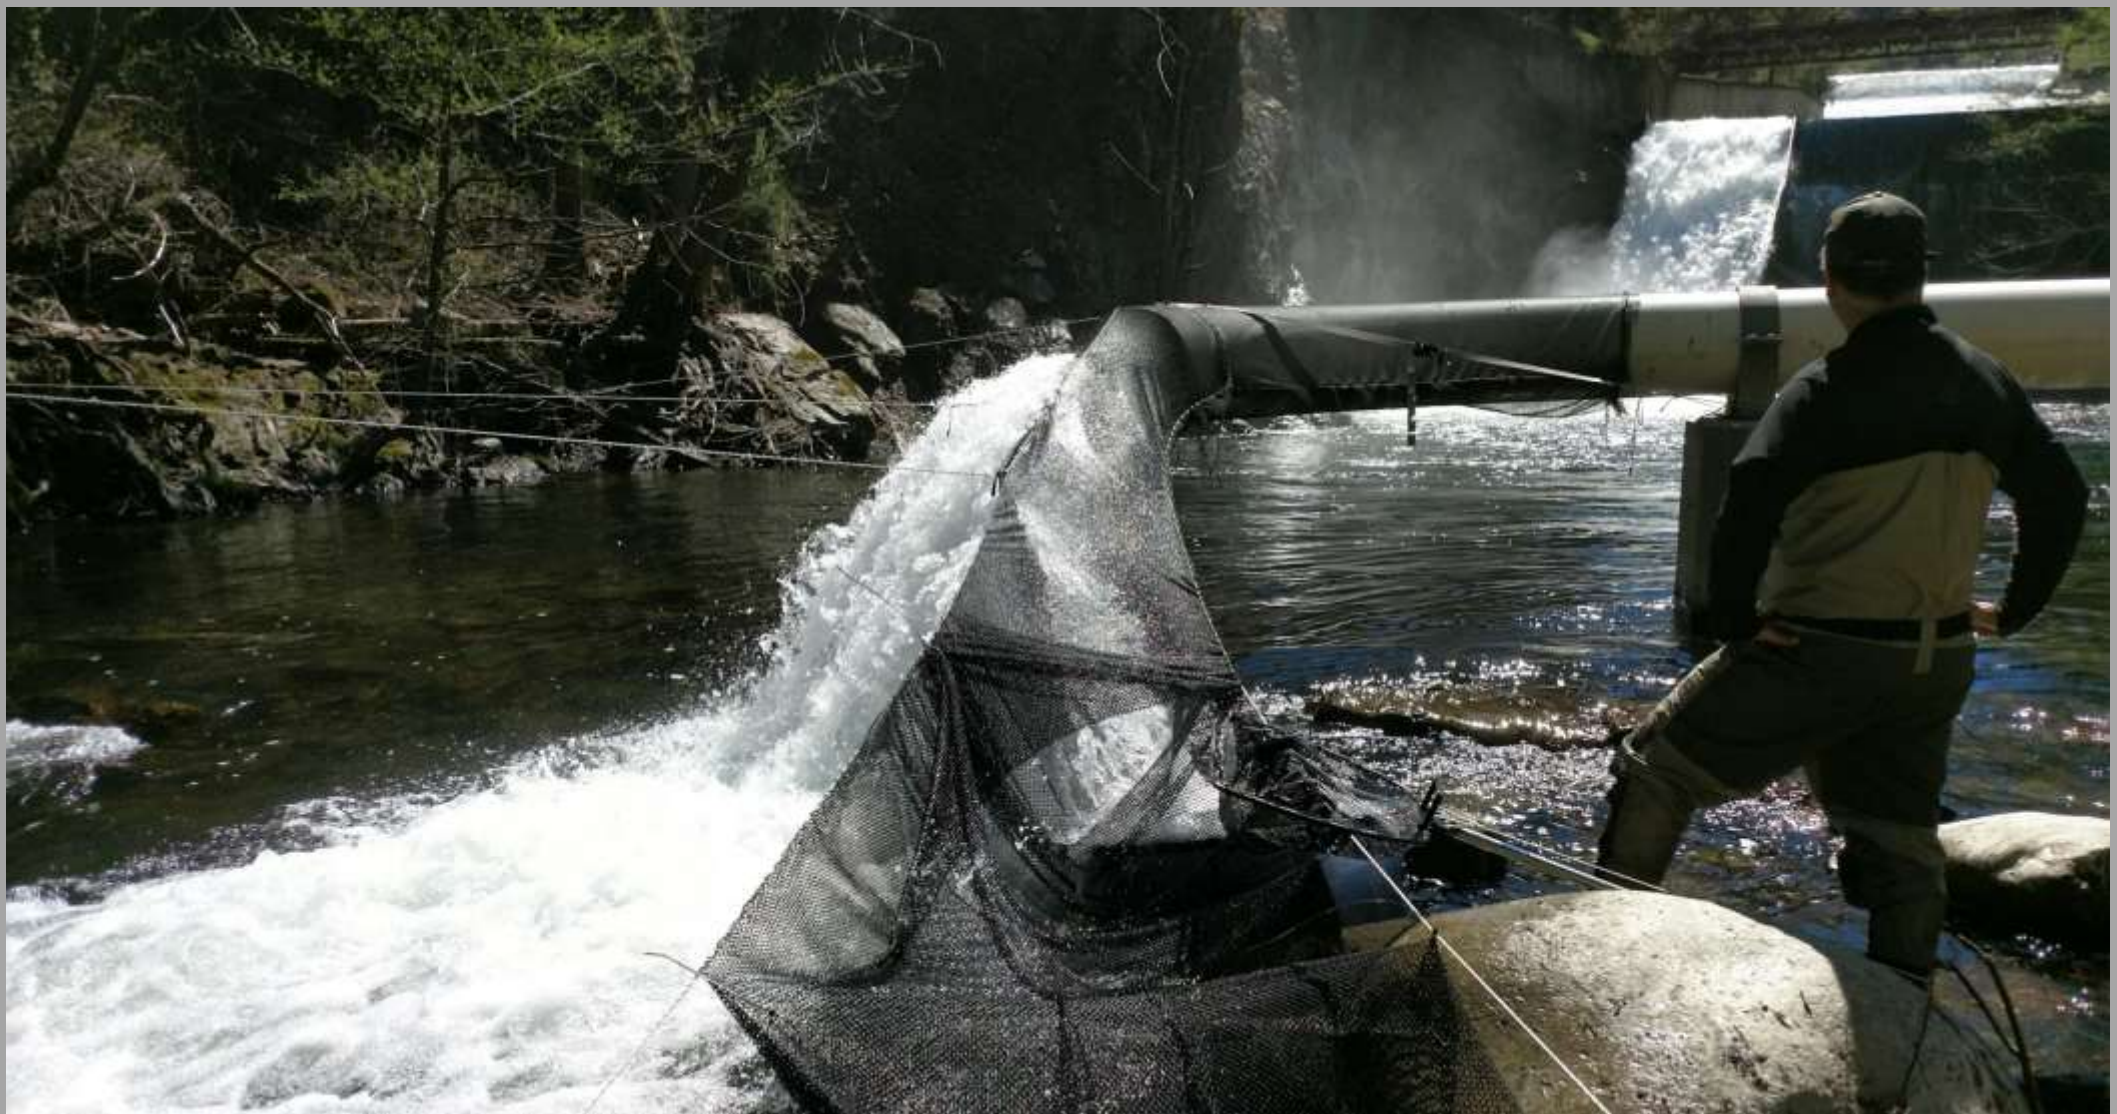
Rigging to secure net at outfall

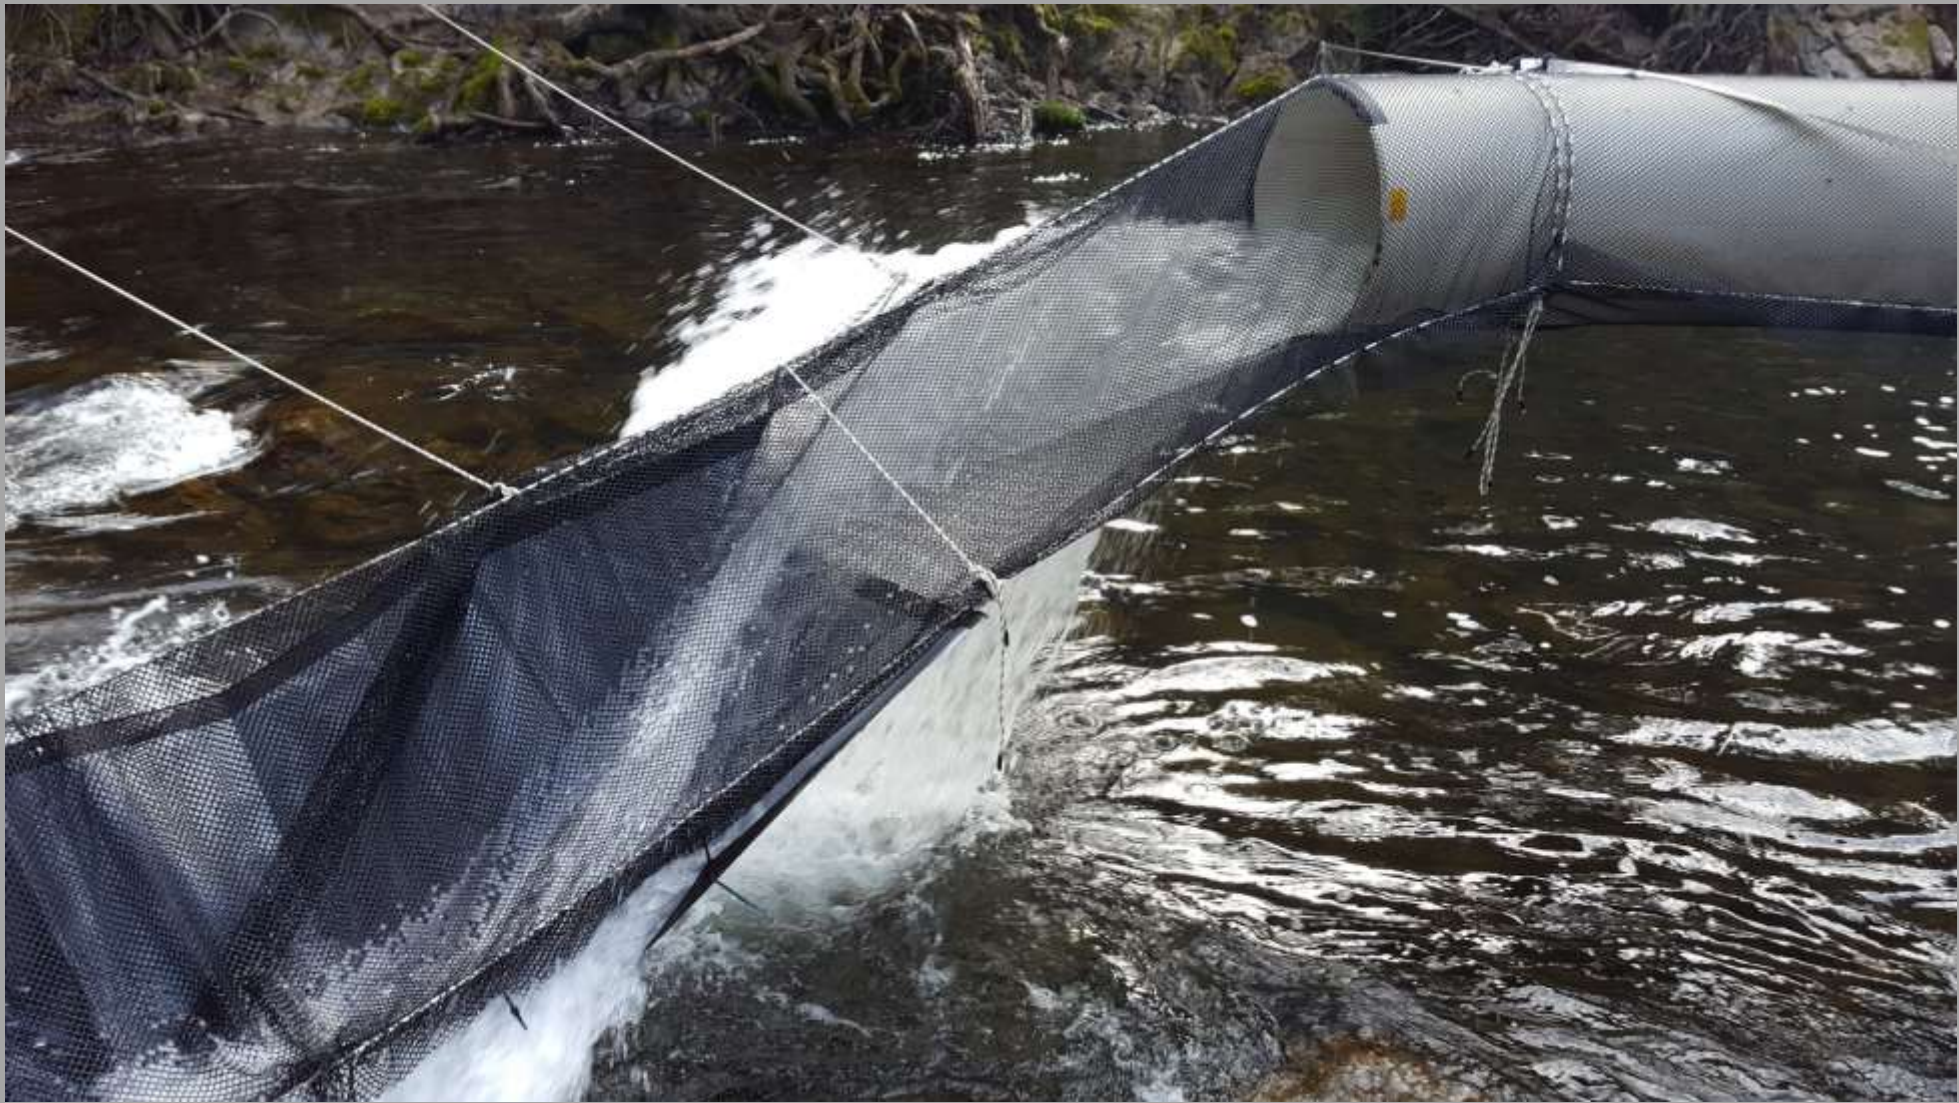
Netting allowed for dewatering much of the outflow while maintaining some flow to carry fish to capture area

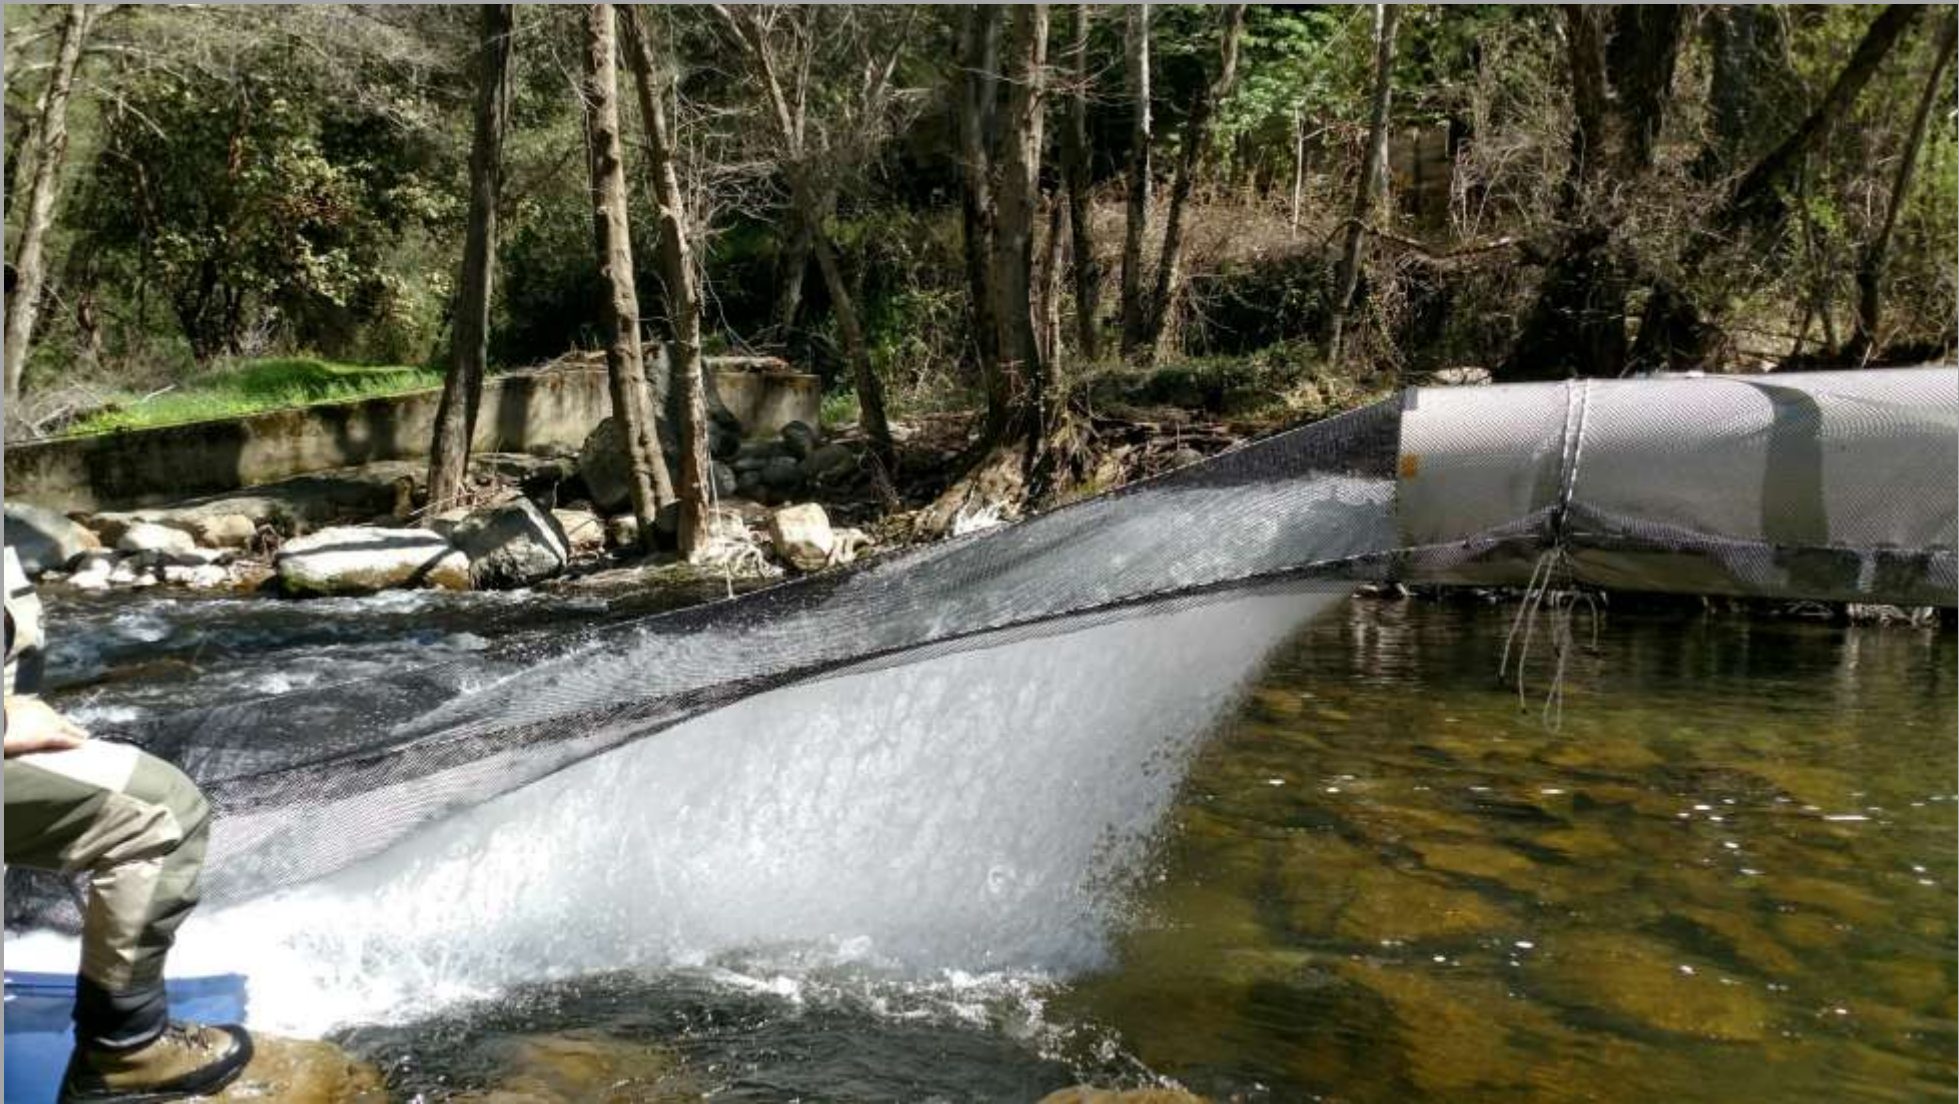
For low flow tests a piece of tarp was added to the netting to carry water to capture point

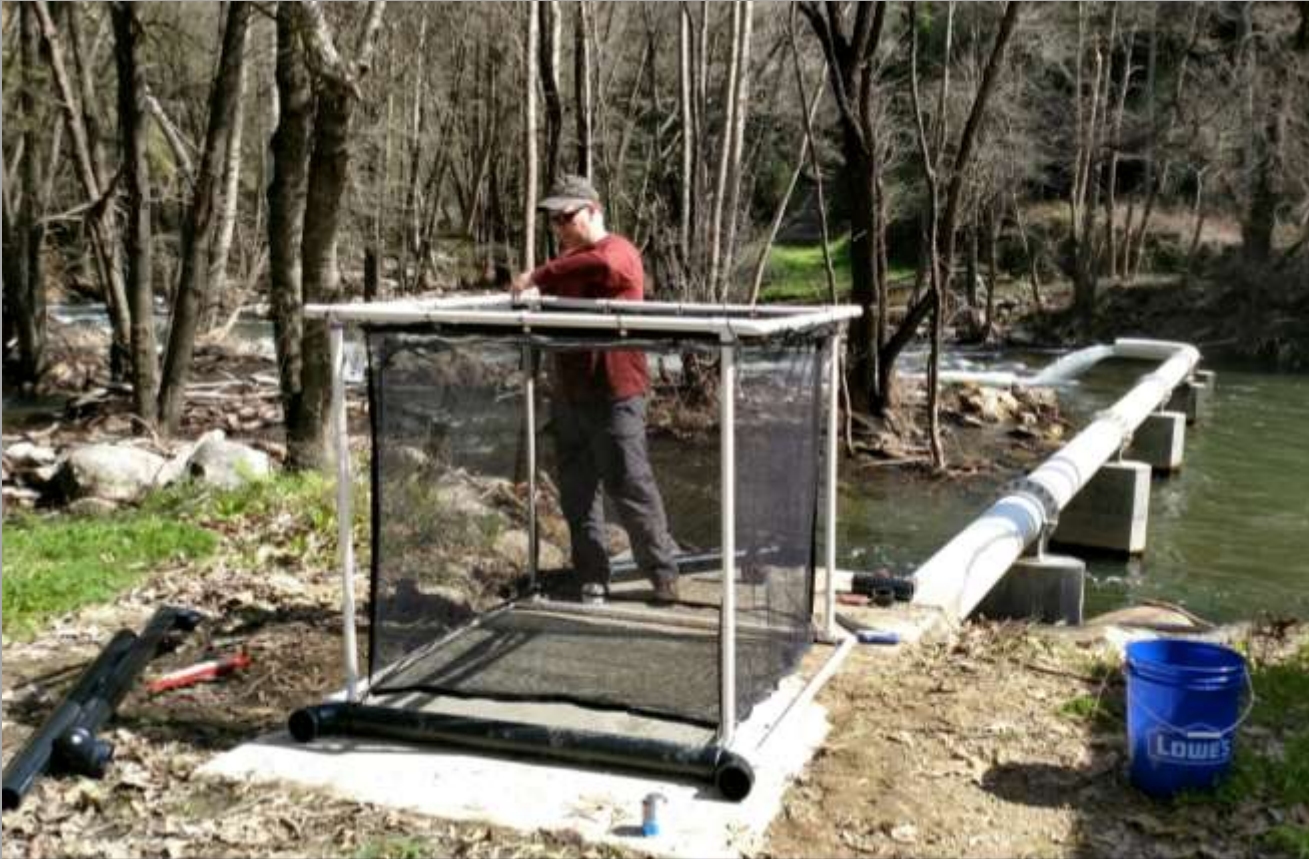
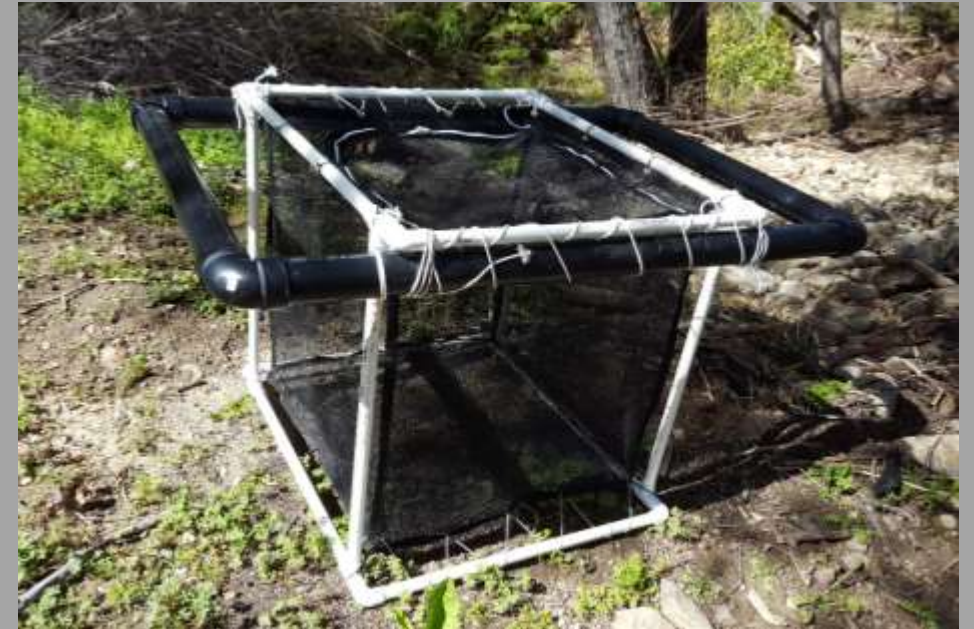
During High flow tests netting dewatered outflow but had enough remain to carry fish to capture area

Net pens constructed using prefabricated cube shaped nets with 3/8" knotless mesh and zippered tops to facilitate fish transfer.

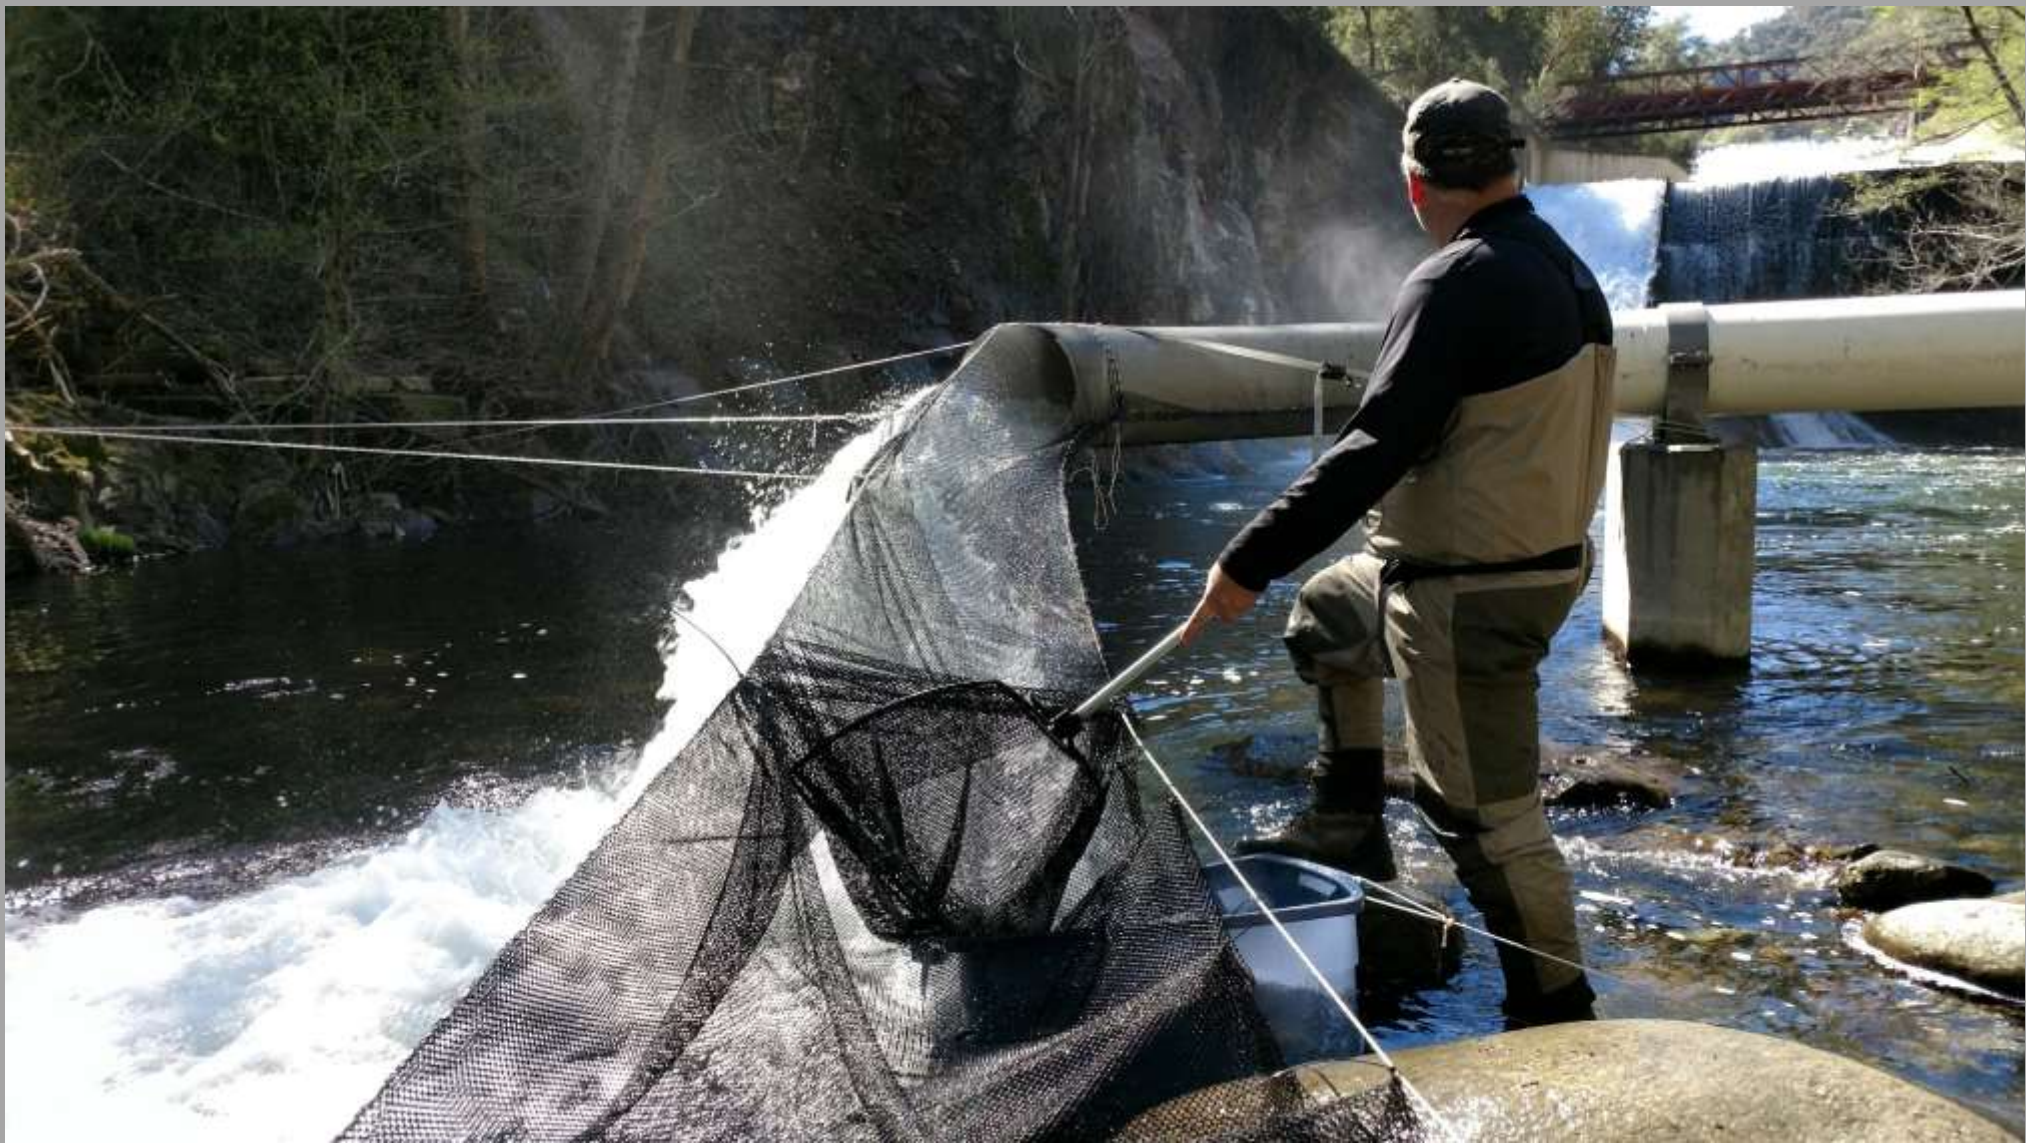
Fish were collected from capture net and immediately placed in live-well container with river flow for holding until examination

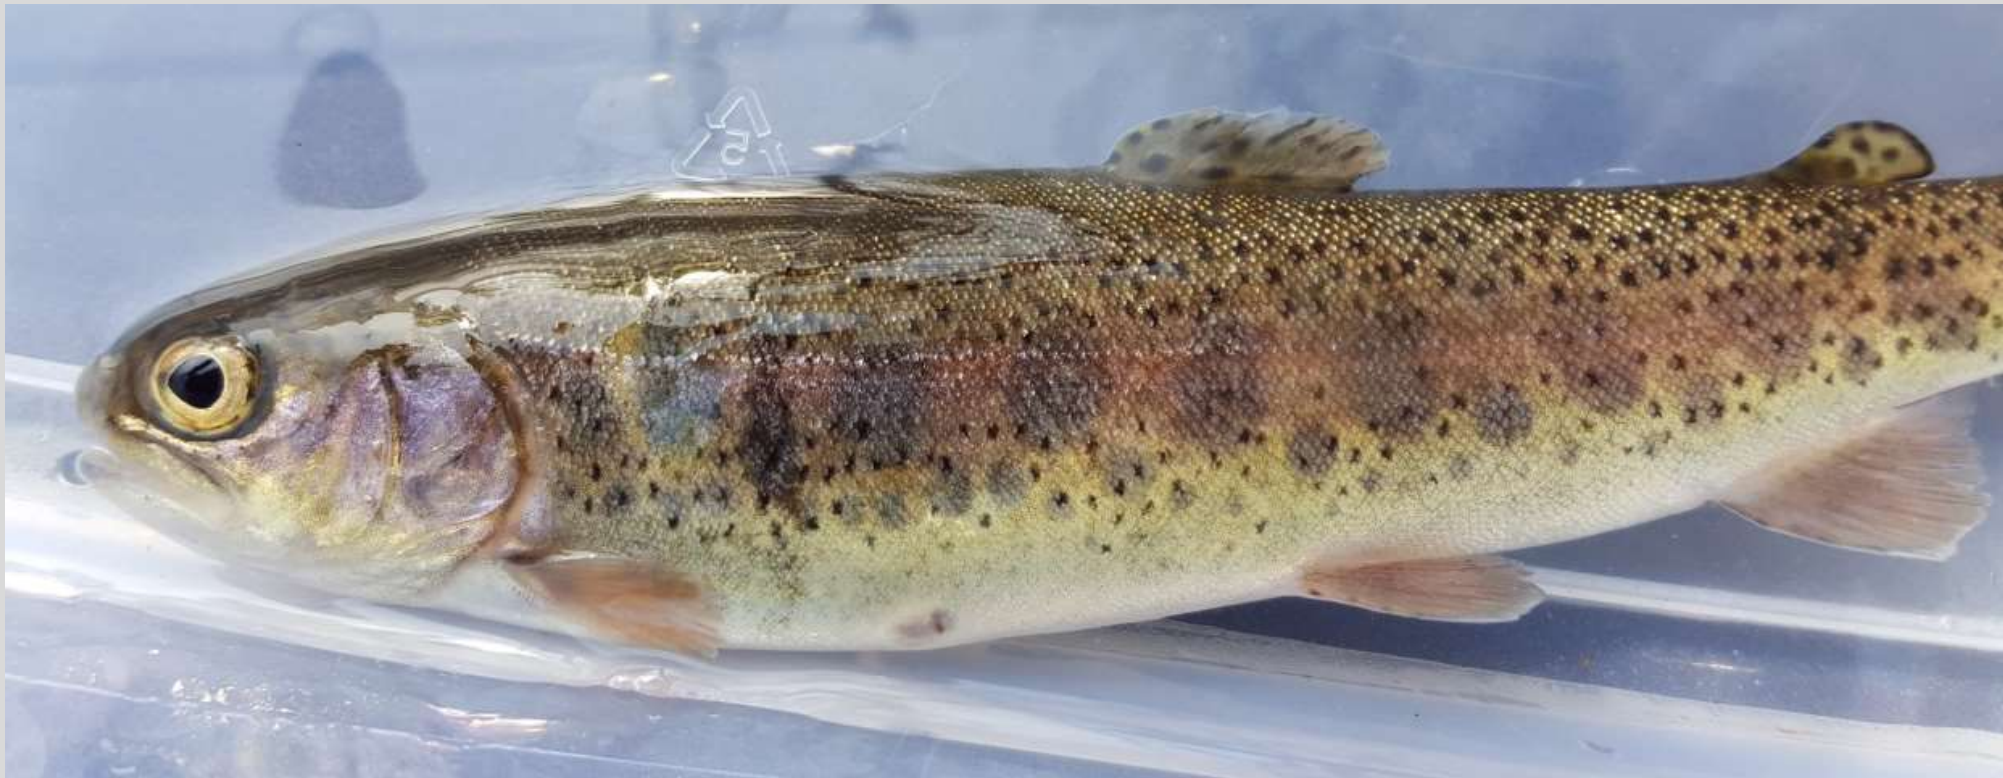
One fish from 9cfs, FWC release had narrow vertical bruise on left side of body

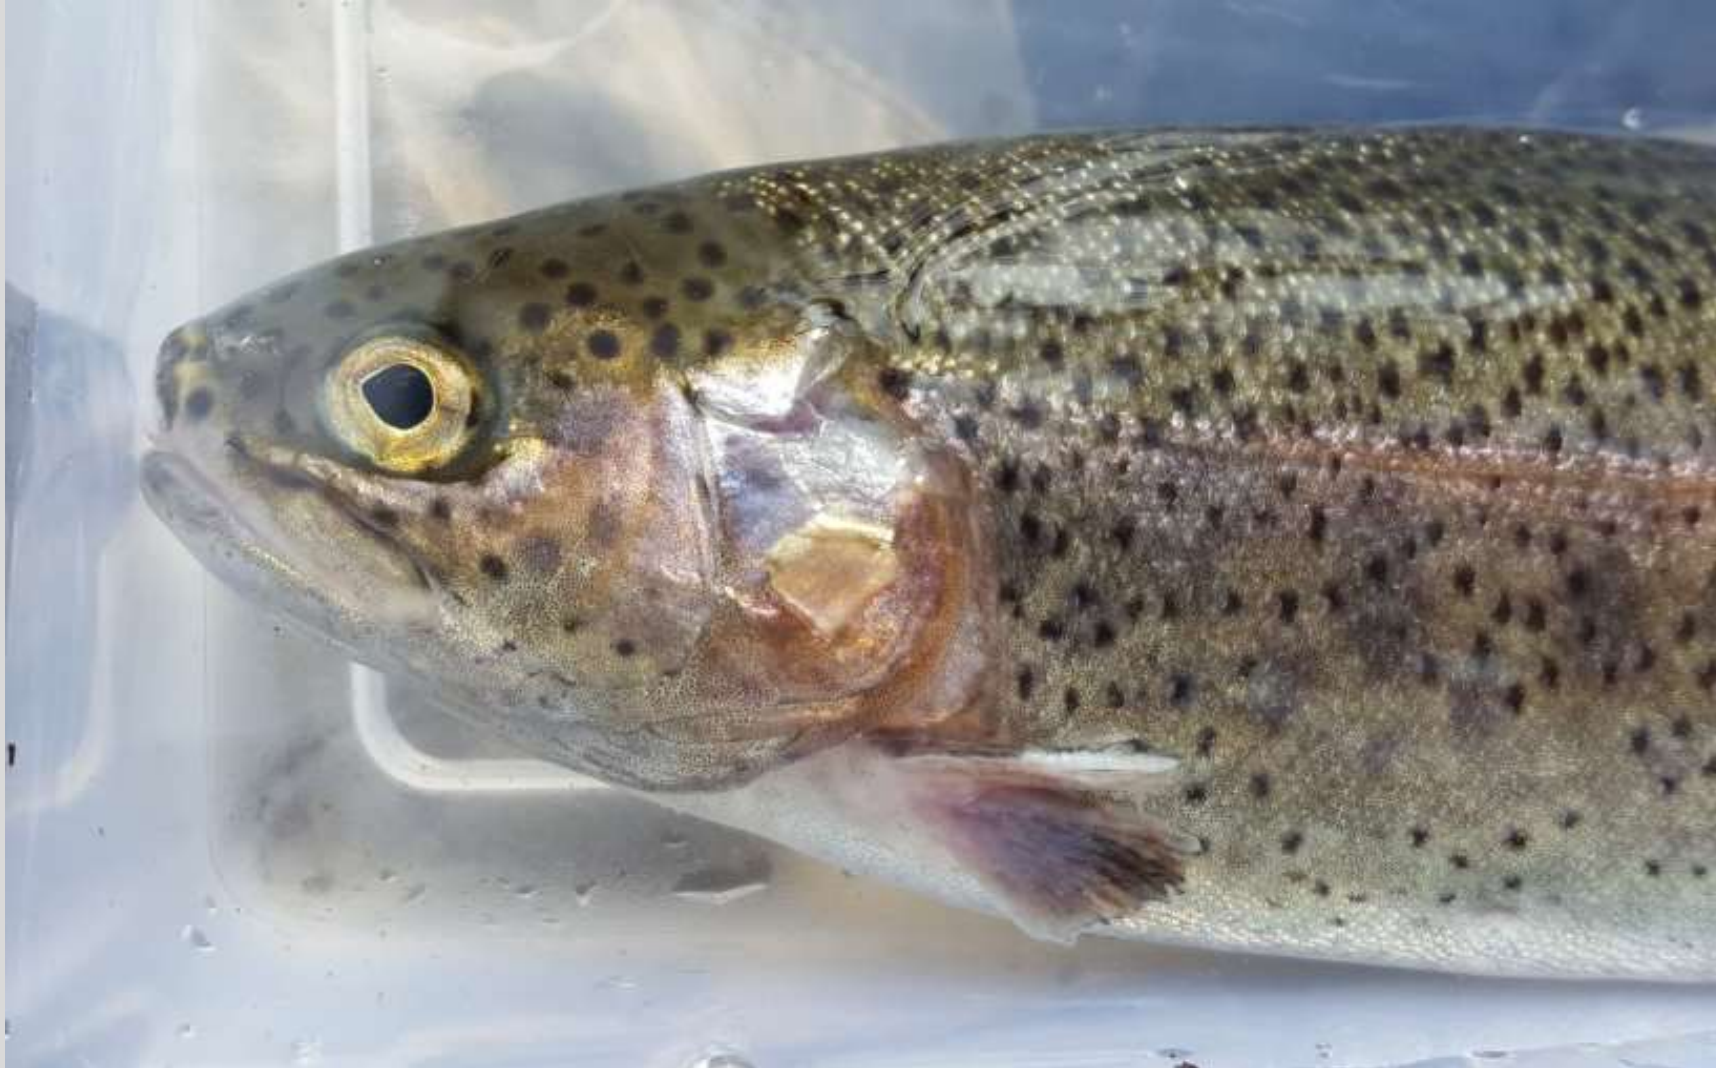
One fish from 5cfs, FWC release, had torn opercula

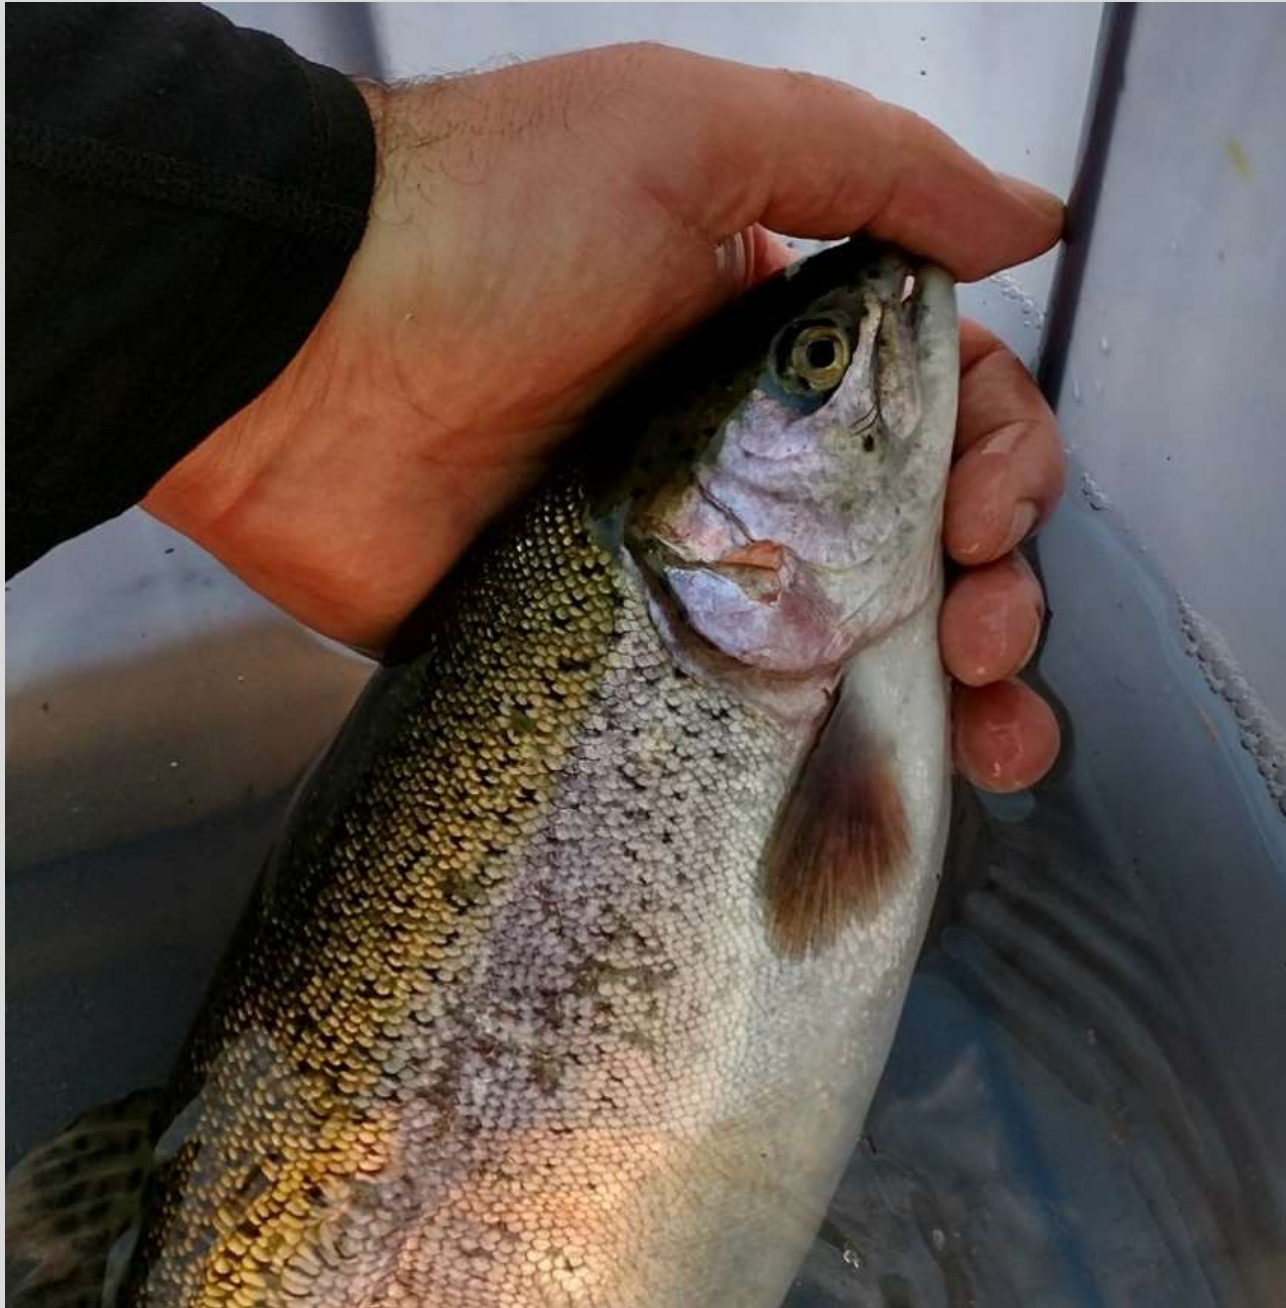
One Adult sized
fish from the
5 cfs test had a
tear in opercula
and minor
descaling

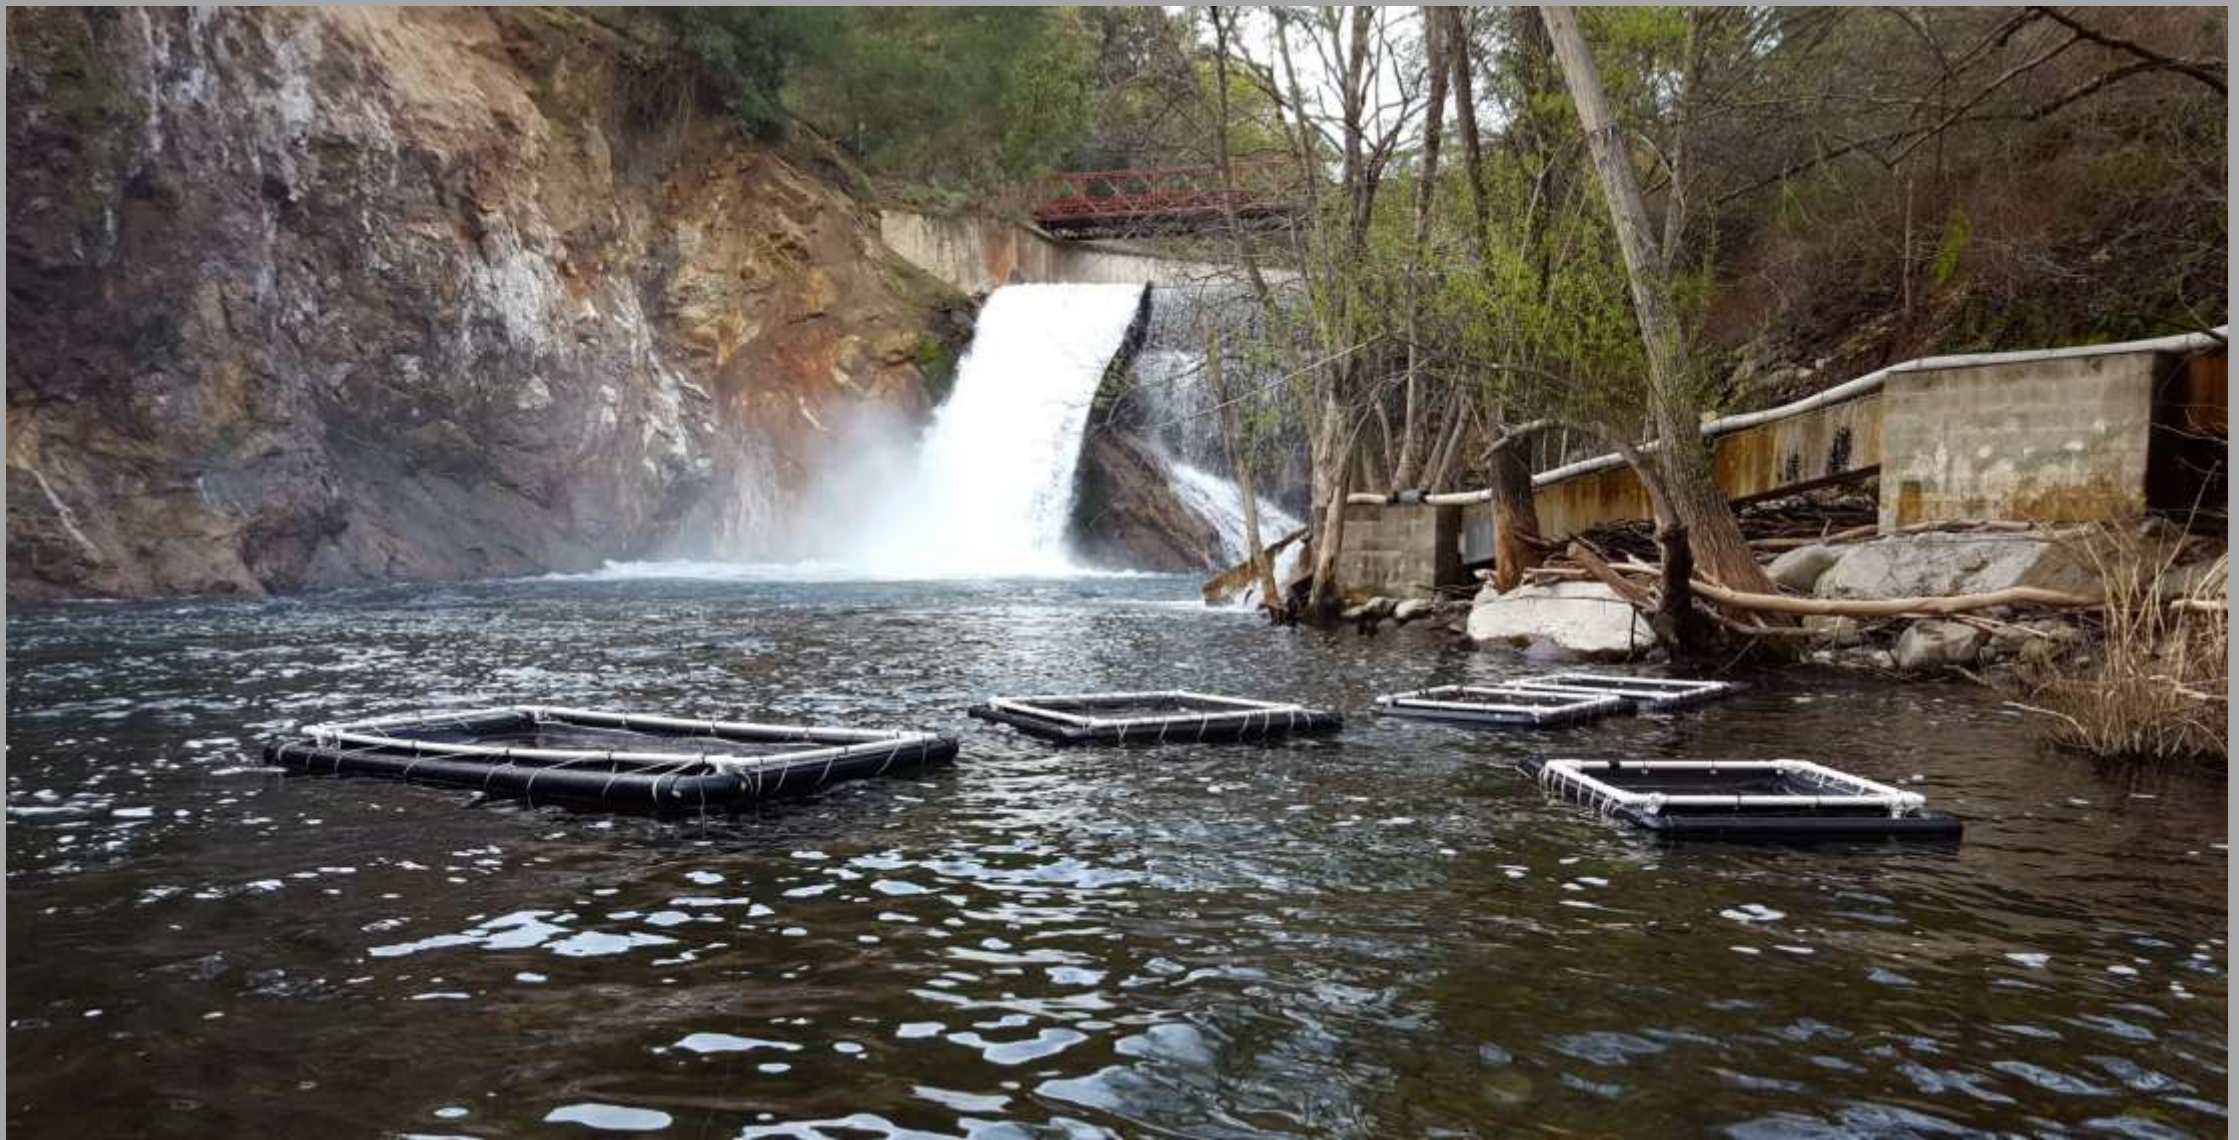
Test fish kept in floating net pens for 48 hours after testing
